Failure Analysis of Nonvolatile Residue (NVR) Analyzer Model SP-1000

Joseph C. Potter¹
University of Michigan, Ann Arbor, Michigan, 48109

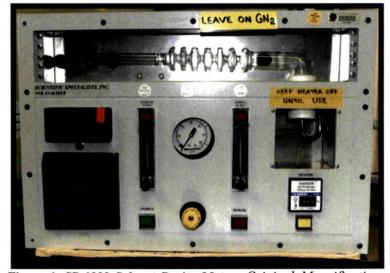
Figure 1. SP-1000 Solvent Purity Meter. *Original Magnification:* 0.25X

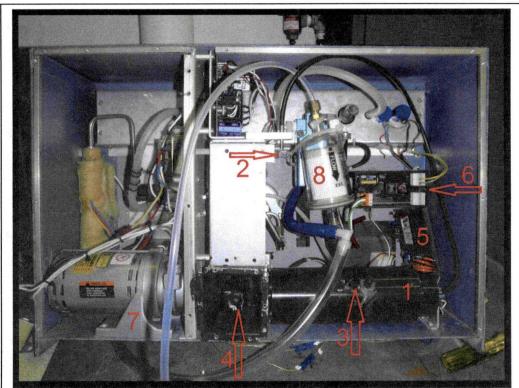
Figure 2. Rear View of SP-1000 with back panel removed. Items indicated are 1. Illumination Chamber, 2. Light Source, 3. Smoke Tube, 4. Photomultiplier Tube, 5. Amplifier circuit Board, 6. Digital Panel Meter, 7. Vacuum Pump, 8. HEPA Filter.

The signal from the photomultiplier tube is transmitted though the amplifier circuit board (Fig. 2, Item 5) which amplifies the signal into a reading displayed on a digital panel meter (Fig. 2, Item 6).

The vacuum pump (Fig. 2, Item 7) is connected by means of Teflon tubing to the optical system. The sample aerosol is first drawn through the drying tube, then through the optical system. A solenoid valve switch is provided on the front panel for opening and closing the sample intake. Intake of room air, cleaned by a High Efficiency Particulate Air (HEPA) filter (Fig. 2, Item 8) introduces clean air into the optical system to provide a rapid purge of air when going from contaminated sample to clean room air.

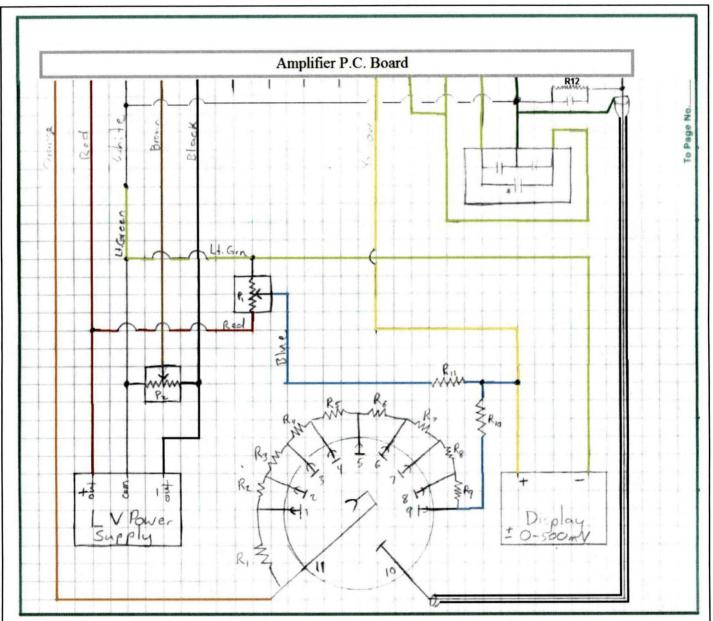
After verifying the optical system to be in good working order the troubleshooting of the electronic system was required. Because no circuit or wire diagrams for the unit were available one was produced to aid in the troubleshooting. This schematic is shown in the appendix.

Figure 3. Electrical Schematic for SP-1000. R_I - $R_g = 478k\Omega$, $R_{I0} = 563k\Omega$, $R_{II} = 28k\Omega$, $R_{I2} = 24.5M\Omega$, LV Power = $\pm 15VDC$, P_I - $P_2 = 10k\Omega$ potentiometer.
